FRENCH STATE FLIGHT SAFETY INVESTIGATION BOARD

INVESTIGATION REPORT

A-2024-02-1

Event date	February 12 th 2025
Place	Salon-de-Provence (France)
Type of aircraft	Extra 330 SC
Organization	French Air and Space Force

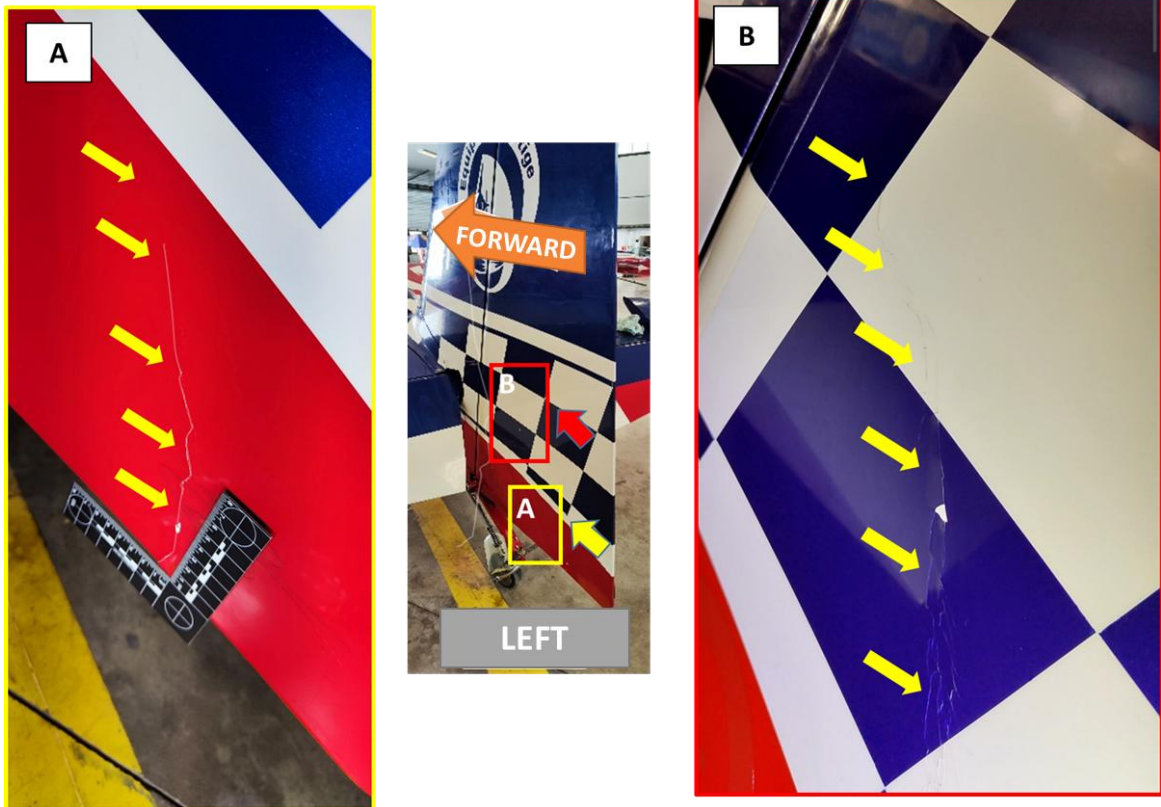
Figure 4 : crack on the left side of the rudder

The crack is visible over 10 cm under the rudder.

The cracking of the aircraft's rudder results from damage to the inner skin of its left panel due to excessive asymmetric bending stress from « left to right ». Flight safety was not affected by this damage.

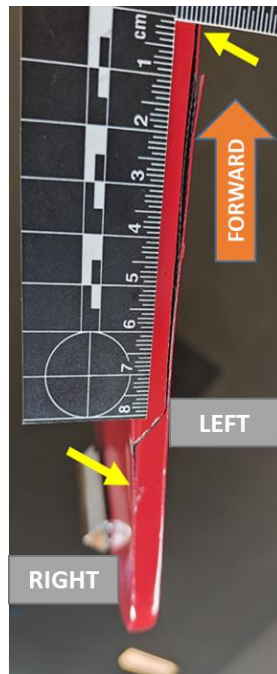
Figure 5 : underside view of the rudder crack

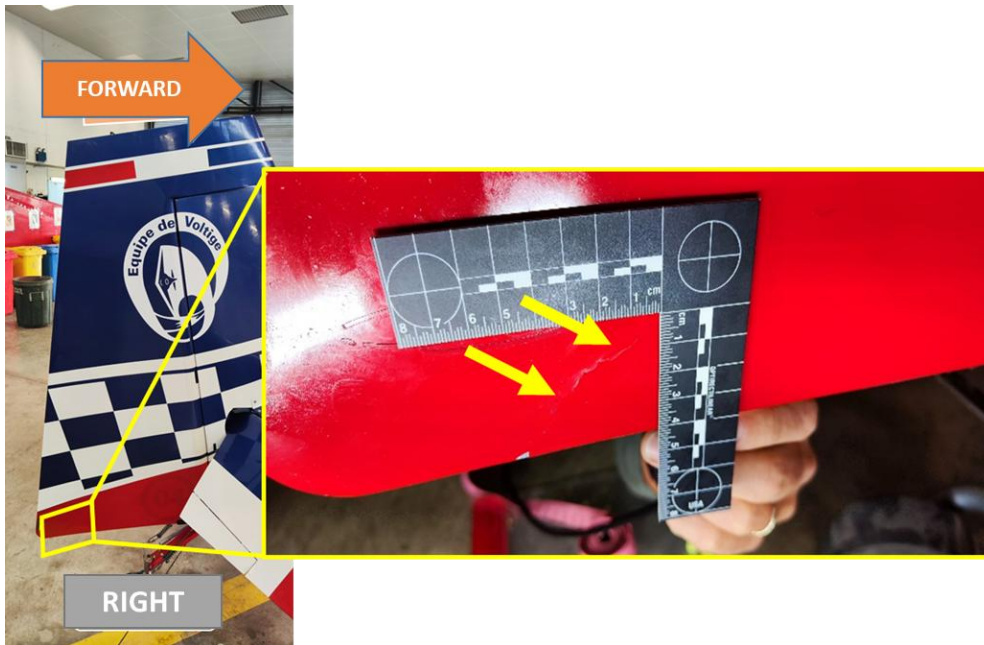
It is also visible on the right side and measures 15 cm.

Figure 6 : crack on the right side of the rudder

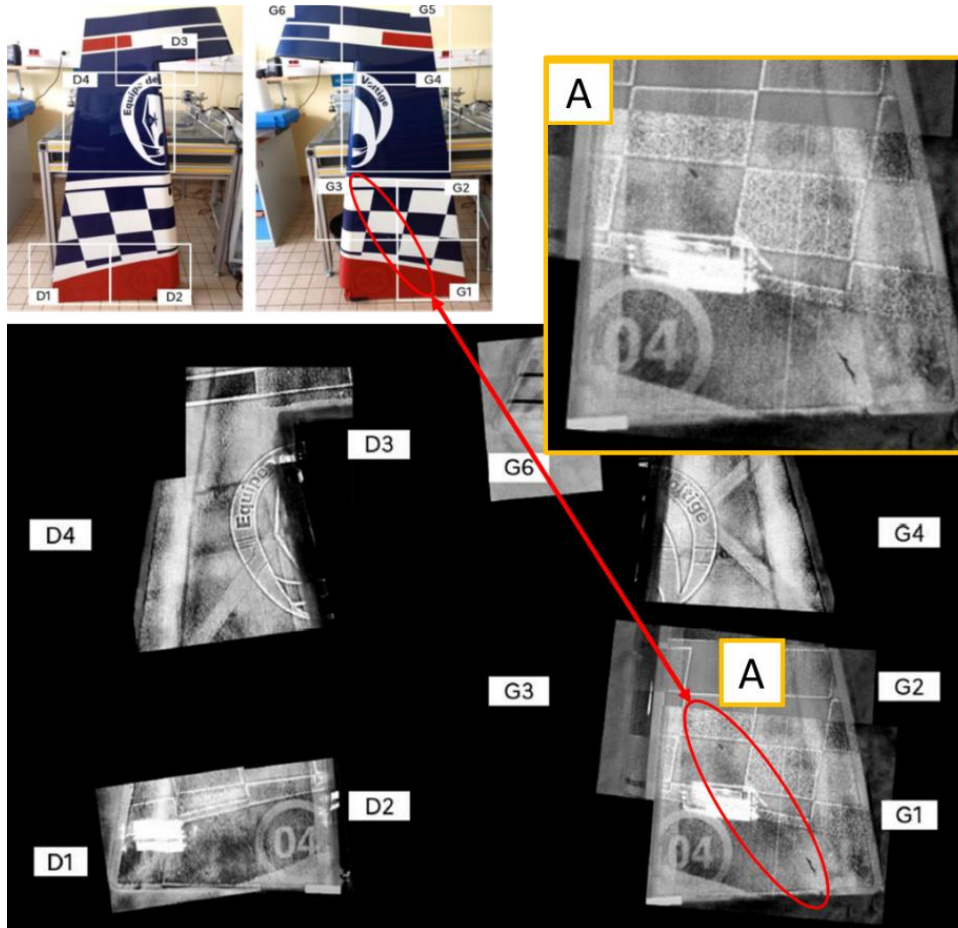
NDT examinations by thermography, then by *bond-tester*²⁰, carried out on the rudder reveal in the left panel of the rudder a propagation in delamination of part of the structure. This delamination is restricted to a strip of a few centimeters on either side of the visible crack. No structural defect is detected in the right panel of the rudder.

Figure 10 : visualization of the crack on the left panel of the rudder by thermography.

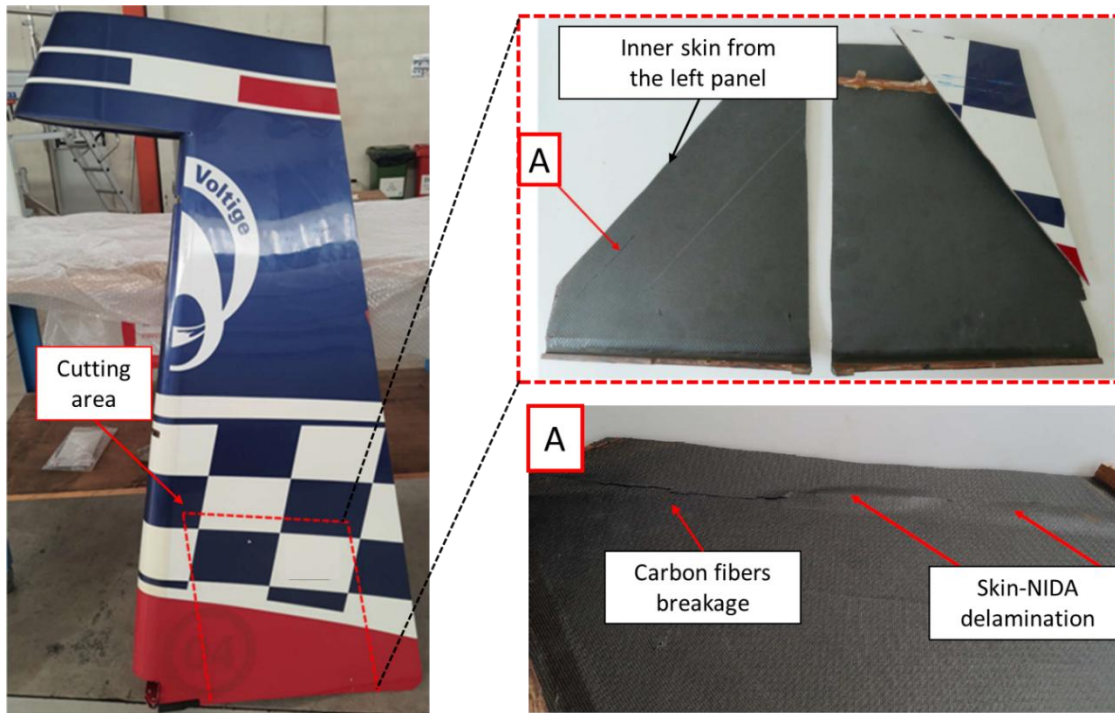
Following NDT inspections, the cracked area of the left panel was cut out. Examination of the cut shows that the inner skin of the left panel is cracked and has a separation from the NIDA over a strip of 20 to 30 mm. The morphology of the crack indicates that the inner skin was subjected to excessive compressive stress. After removing the inner skin, it appears that the NIDA and the outer skin are not cracked.

Figure 11 : cutting of the left panel of the rudder.

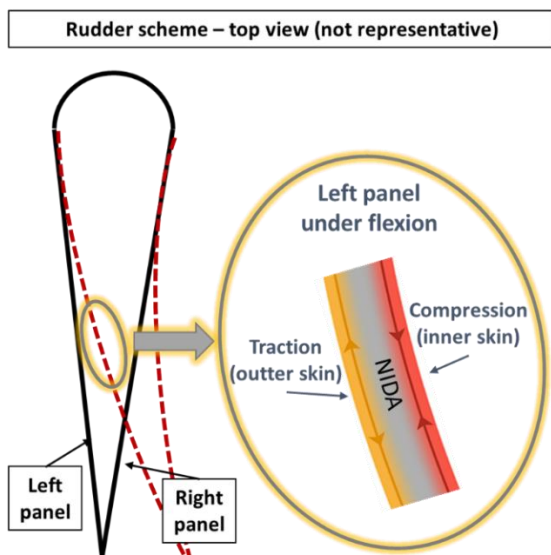
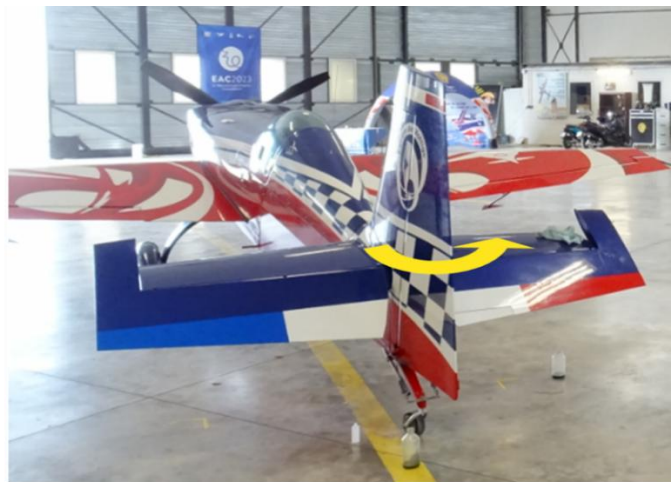
According to these observations, the damage to the rudder is the result of excessive asymmetric mechanical stress of the bending type (bending of the rudder « from left to right ») putting the inner skin of the left panel of the rudder under compression.

Figure 12 : illustration of the "left-right" bending effort on the rudder.

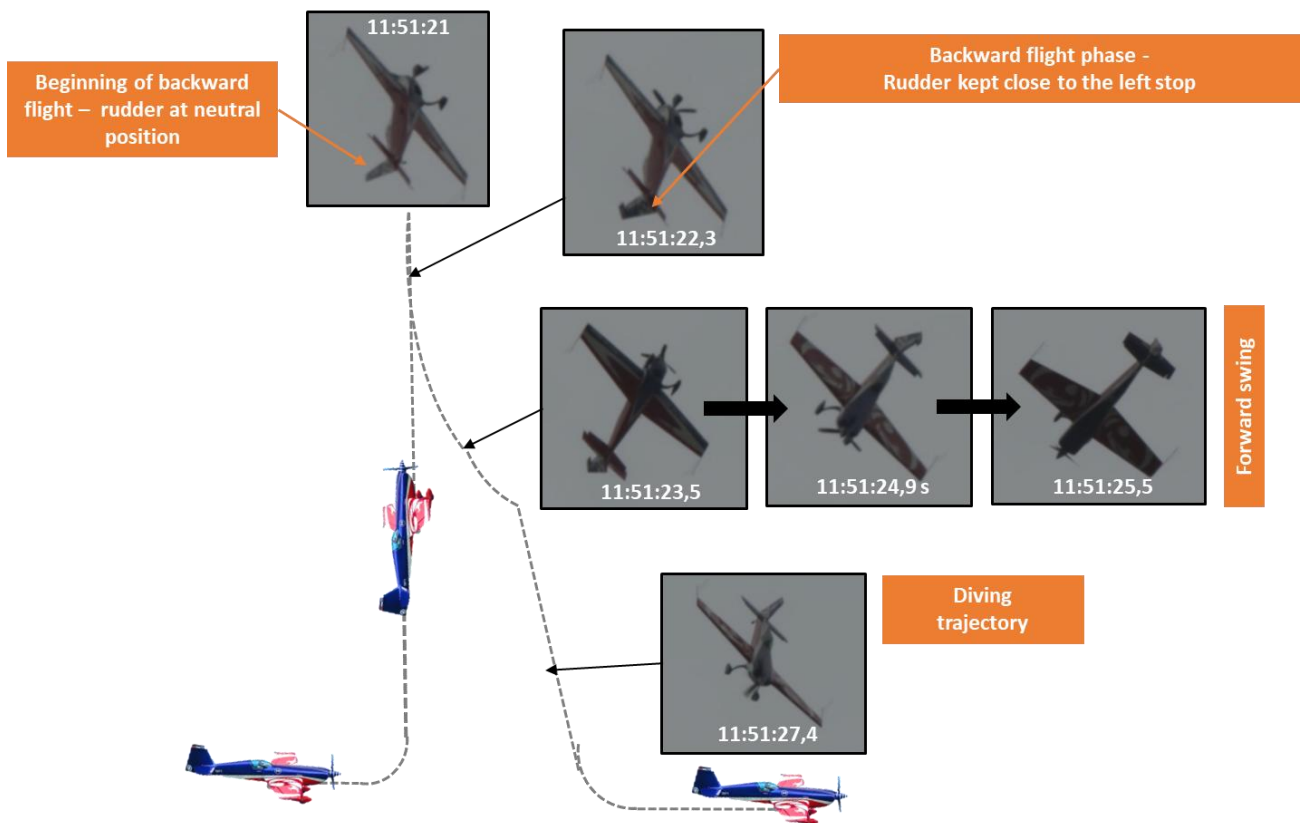
The rudder, which has a travel of $\pm 30^\circ$ from stop to stop, appears to be held at the left stop for a large part of the backward flight of tail-slide n°1 (figure 14).

Figure 14 : illustration of the sequence of tail-slide number 1.

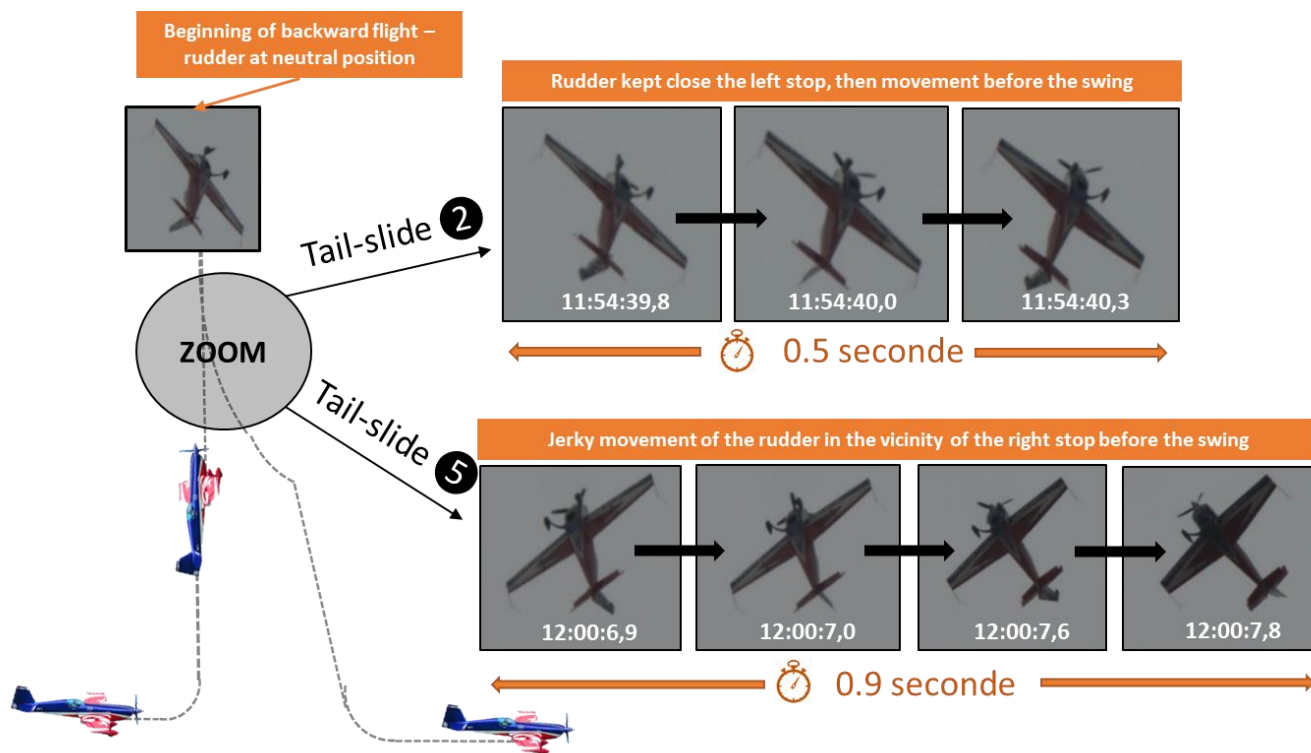
During the backward flight phase of tail-slide number 2, the rudder, initially held in the left stop, undergoes a dynamic « right to left » movement just before the swing of the aircraft (figure 15).

Figure 3 : illustration of the actions on the rudder for tail-slides number 2 and number 5.

The PIC performs the tail-slide figure ten times. On four occasions, beating movements of the rudder are observed at the end of the backward flight phase, and once (tail-slide number 5), the movement very likely takes the rudder to the right stop.

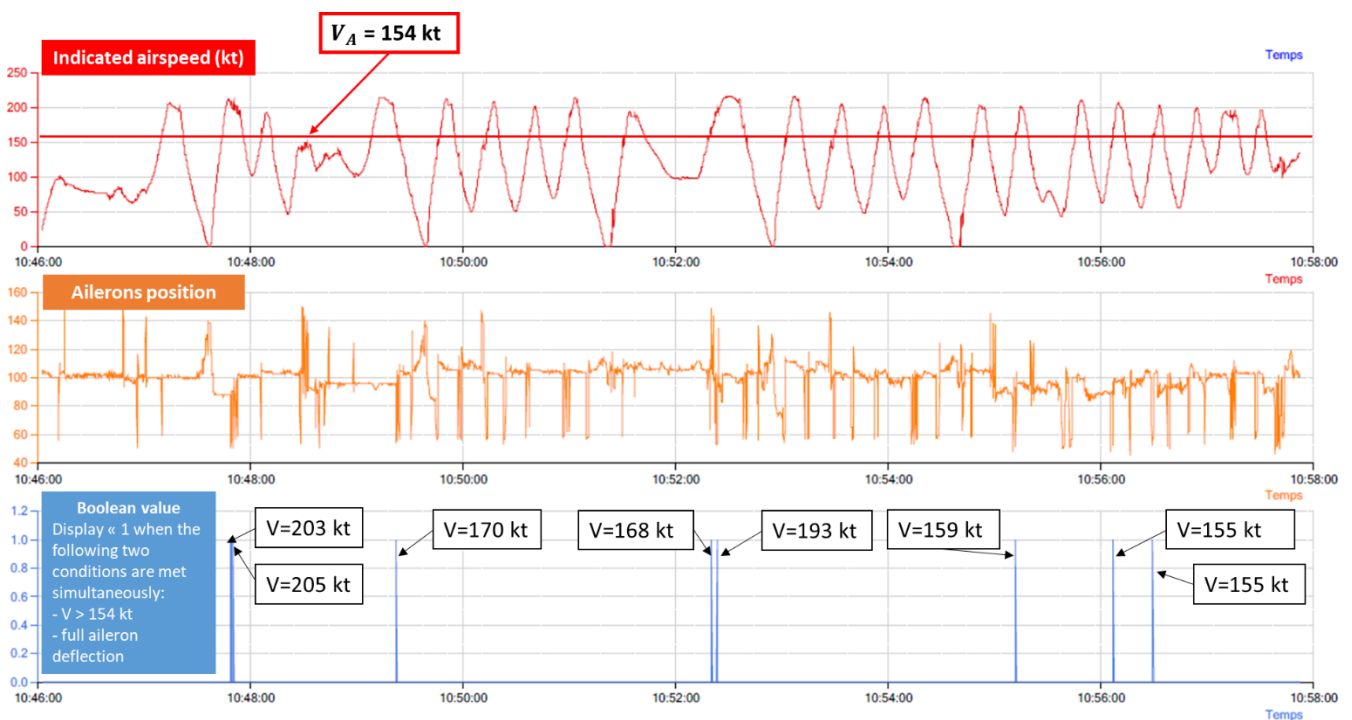
Flight data recorder analysis highlighted eight times during the execution of the « known-free » program full aileron deflection commands at a speed beyond the maneuvering speed V_A , which can reach up to 205 kt, i.e., 50 kt beyond the limit.

Figure 16 : indication of maneuvering speed exceedances with ailerons at full deflection for the flight of the event (time in UTC)

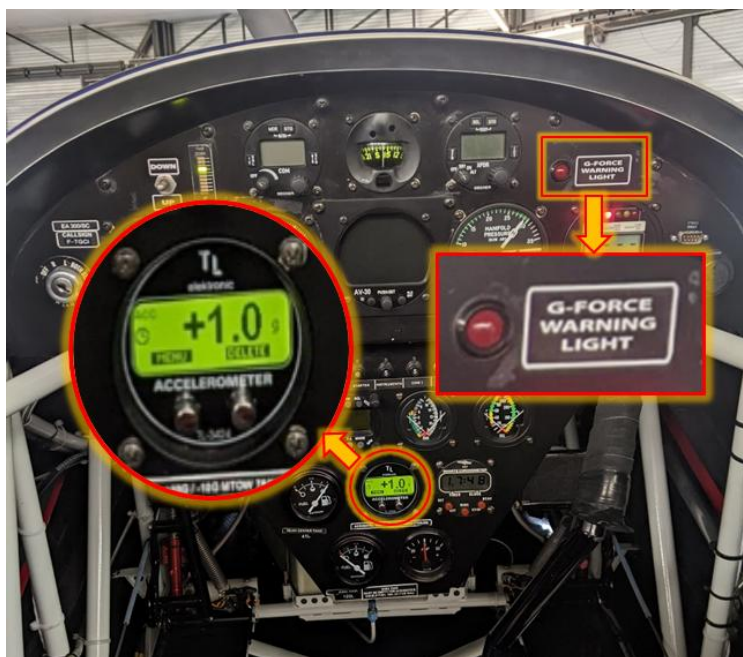
The analysis of the flight's audio recording shows no audible alarm associated with exceeding the maximum load factor (1,800 Hz alarm). This observation aligns with the pilot's testimony (no activation of the red warning light in the cockpit in case of exceeding the limit) and the engineer responsible for the post-flight inspection (no alert message on the accelerometer screen in case of exceeding the limits).

Figure 17 : accelerometer and warning light position in the cockpit of the Extra 330 SC

to Extra Aircraft, to confirm that the reference values used for the load factor ensure an accepted level of safety, and to detail the conditions for activating the accelerometer alarm.
