MANDATORY BULLETIN
No BO-112/2005 SWIFT S-1

DESIGNATION-TYPE/MODEL: SWIFT S-1

CONCERNS: Control column and stop in elevator control circuit

WORKING INSTRUCTION
INSPECTION OF CONTROL COLUMN
IN ELEVATOR CONTROL SYSTEM
OF SWIFT S-1 GLIDER

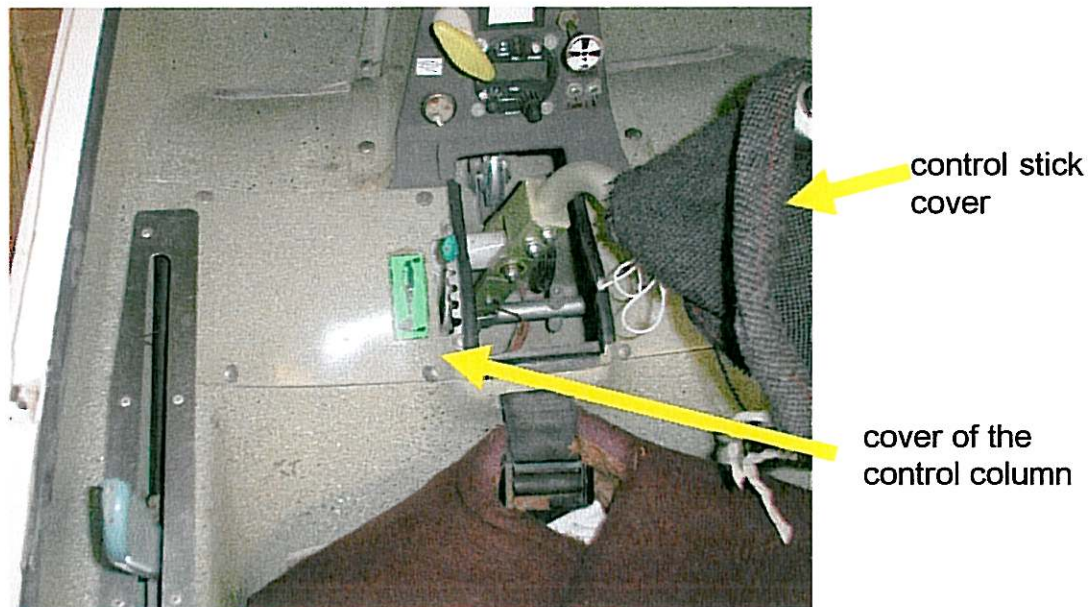
picture 1: Cover of the elevator controls

- I) Dismantle the control stick cover and remove the left (in flight direction) access cover of the controls close to the control stick (s. picture 1).
- II) Inspect the welding seams of the attachments (see circles in picture 2) over the whole length for cracks and other damage; use a strong pocket lamp and a mirror - if necessary. If crack or other damage is found, the control column must be replaced.

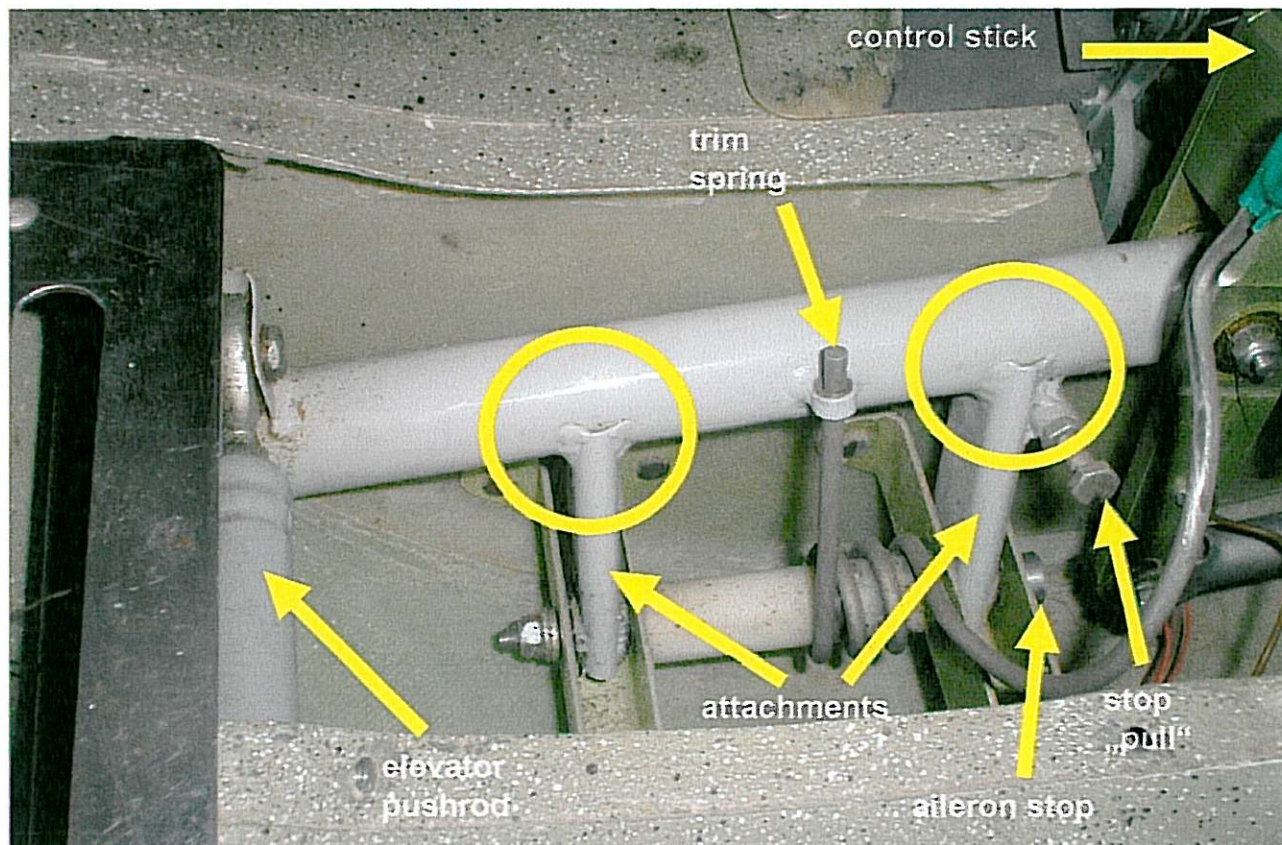
At the glider inspection, on one Swift S-1, the cracked welding joints have been found at the attachment points of control column Part No. A/2-1.00.200, left to the control stick, in the elevator control system.

picture 2 : Elevator control column

When exchanging the elevator control column, pay special care to the bolt mounting the column with its bearings, as the head of this bolt is at the same time the stop for the aileron (see picture 2). Therefore it is necessary that the washers and spacers (if installed) are fitted at the same position when the new column is assembled.

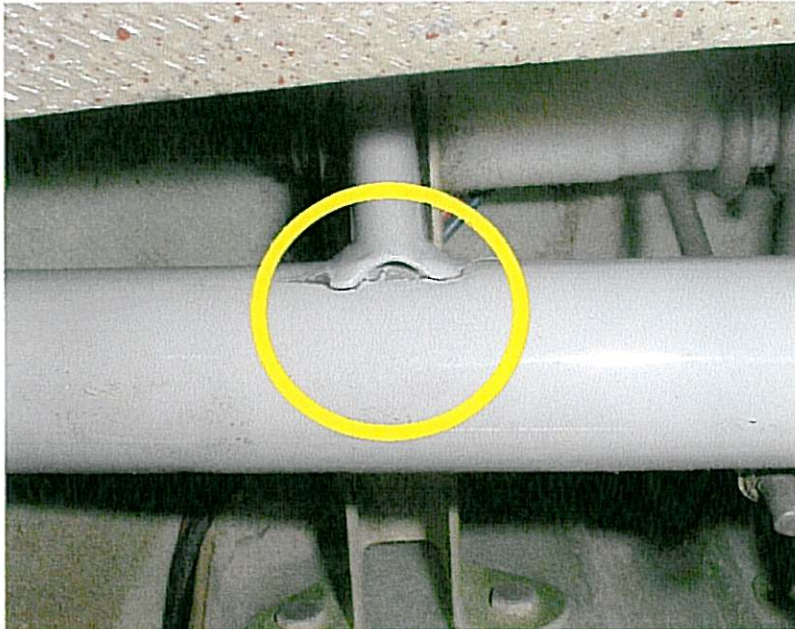
picture 3: Damage viewed from front

picture 3 and picture 4 show a sample of the possible damage.

Action 2. If evidence of damage has been detected at the attachment points in Action 1 above, the control column must be replaced with a new one, delivered by the aircraft manufacturer. The elevator deflections must be checked afterwards and adjusted (if exceeding the limits) in accordance with the glider Technical Service Manual.

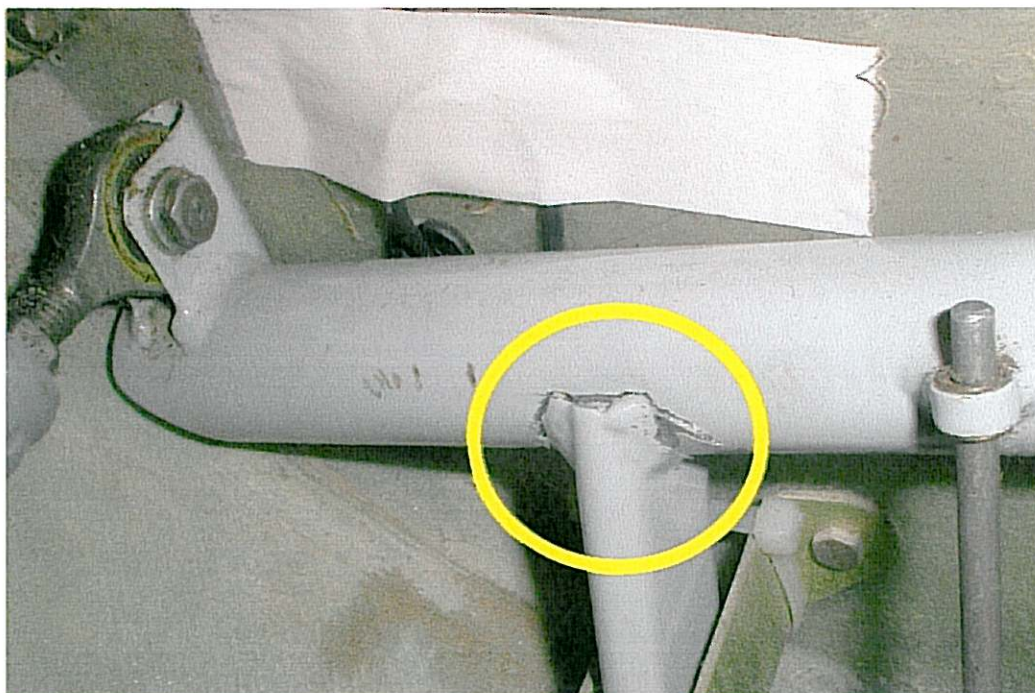
picture 4: Damage viewed from behind

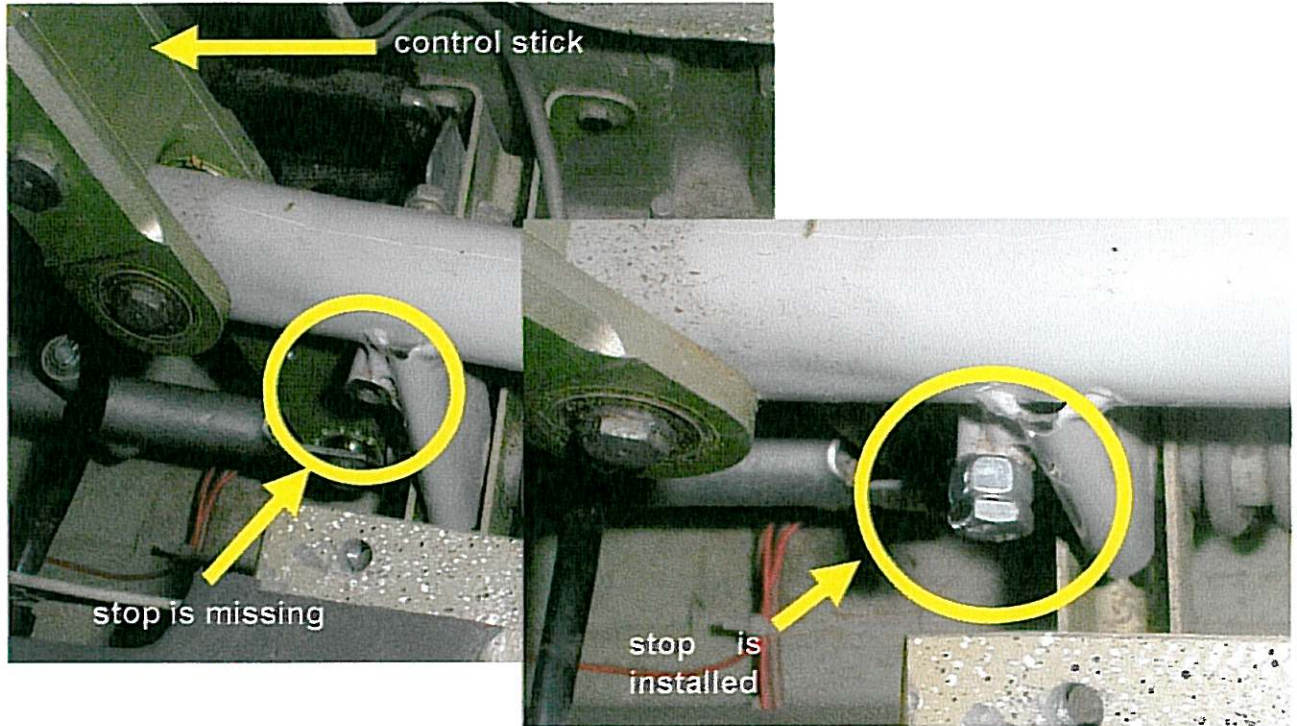
On the same aircraft, it has been observed also that, direct at the control stick only one adjustable stop has been installed in the elevator control for the „nose up“ (pull) position. For the „nose down“ (push) position, the stop was at the outer (left) end of the control column on a GFRP-bulkhead. This can result in an unacceptable torsional load to the control column.

picture 5: Check of the stop for elevator „nose down“ (viewed from front)

III) Check if a stop is installed on the control column for the „nose down“ (push) position. If no stop (bolt M6) is found, this must be retrofitted according to part 2 of this Working Instruction.

The bolt M6 x 20 must be screwed into the existing thread on the front face of the control column and locked with the nut M6 (see picture 5).

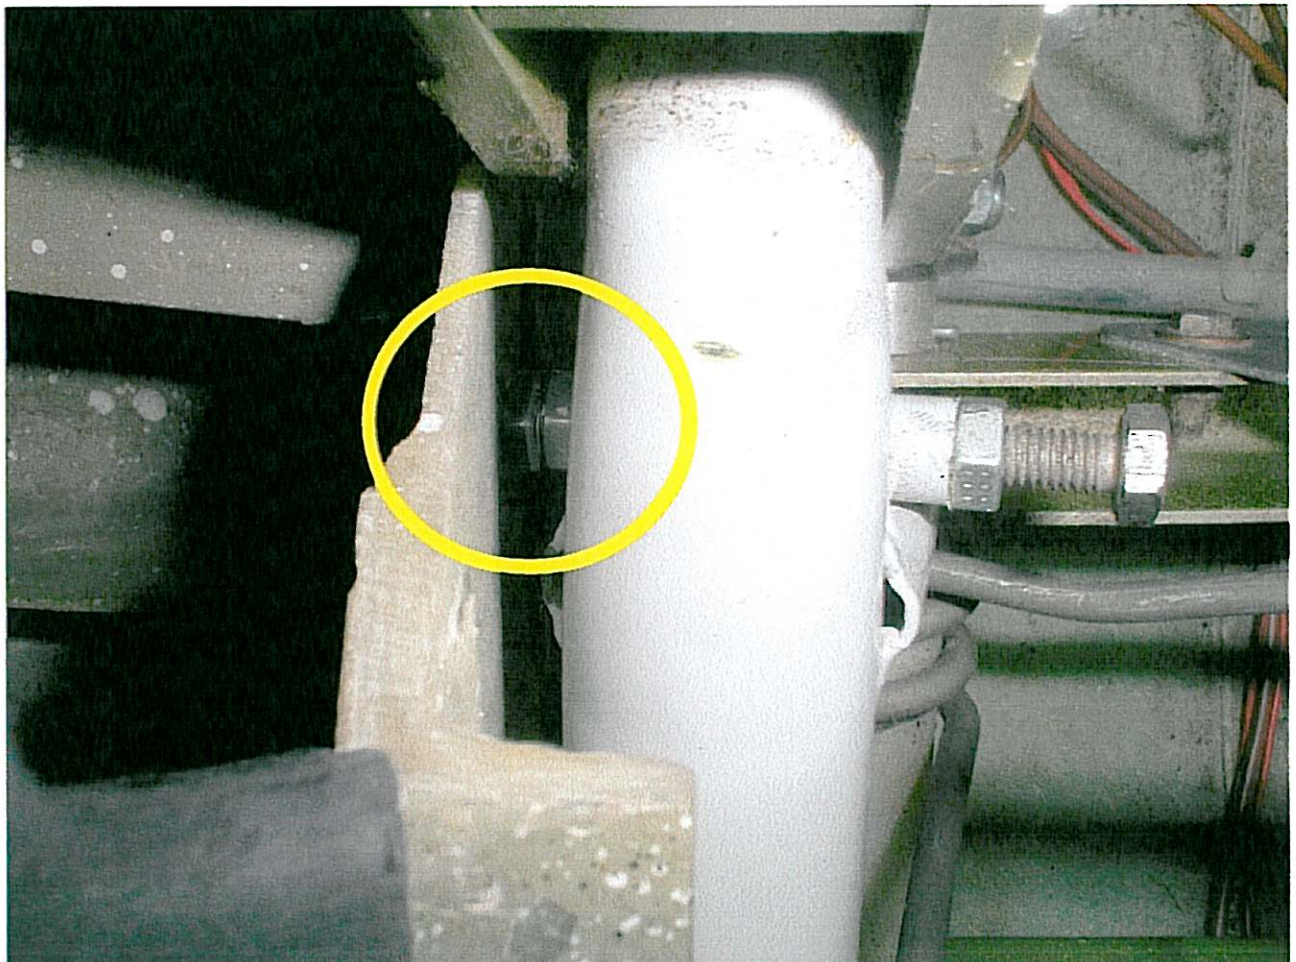
picture 6: Control column pushed fully forward until the stop

The head of the stop bolt must be adjusted so to hit the front control bulkhead prior to the contact between attachment of the elevator push rod at the outer side (sheet metal-U, see picture 7) and GFRP frame!

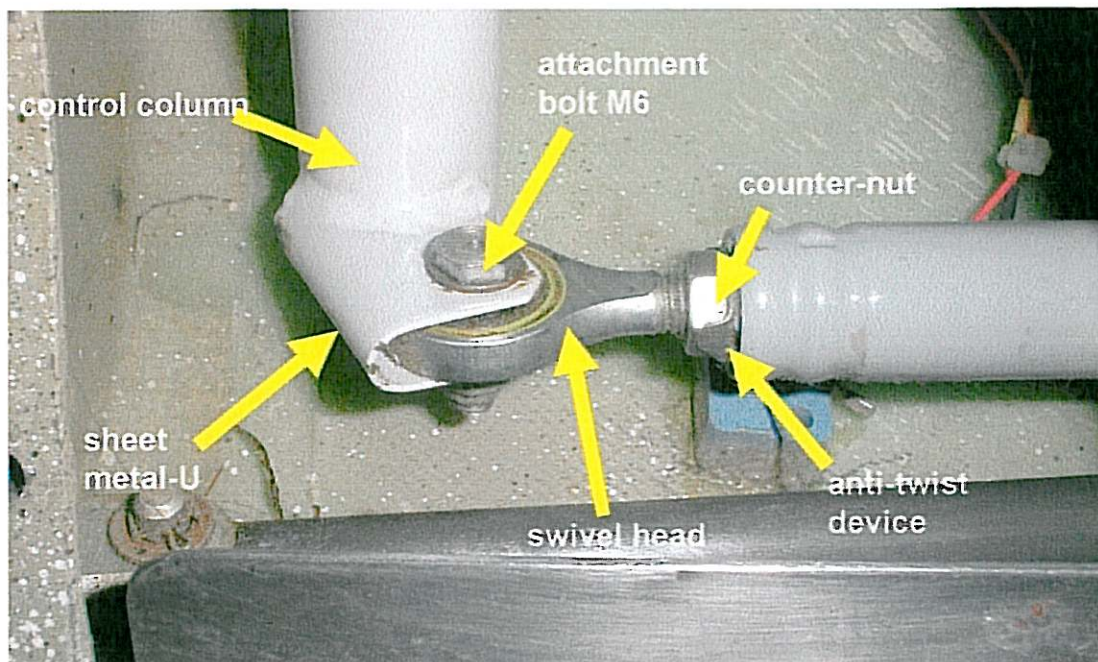
picture 7: Swivel-head at the elevator pushrod fixed by a locknut and secured

To do so, untighten and disconnect the bolt M6, one connecting the push rod end with the column, mark the positions of the washers and keep all these items. Bend off the anti-twist lock at the counter-nut (sheet metal clip), unthighten the counter-nut and screw the swivel head into the pushrod until the elevator deflections in „nose down“ direction reach the required value (see picture 7 and picture 8).

Finally, tighten the counter-nut of the swivel-head and secure it against loosening with the anti-twist device. Connect the pushrod with the control column by means of the M6 bolt, use the washers as marked when disassembling the set. Use a new lock nut M6.

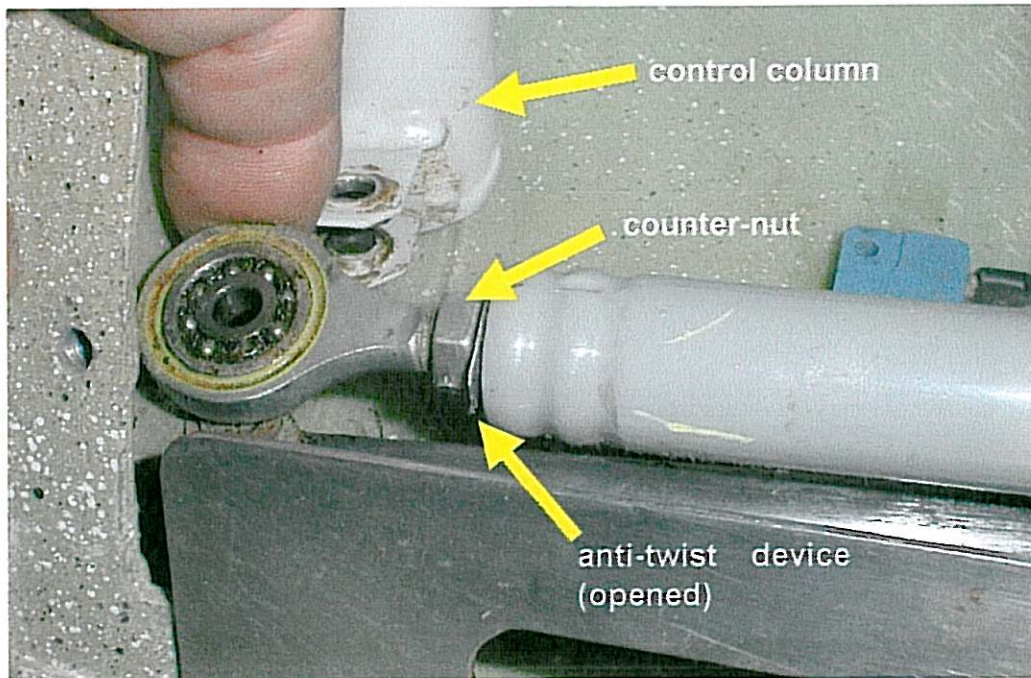
picture 8: Swivel-head disconnected and counter-nut untightened
