FRENCH STATE FLIGHT SAFETY INVESTIGATION BOARD

INVESTIGATION REPORT

A-2024-02-1

Event date	February 12 th 2025
Place	Salon-de-Provence (France)
Type of aircraft	Extra 330 SC
Organization	French Air and Space Force

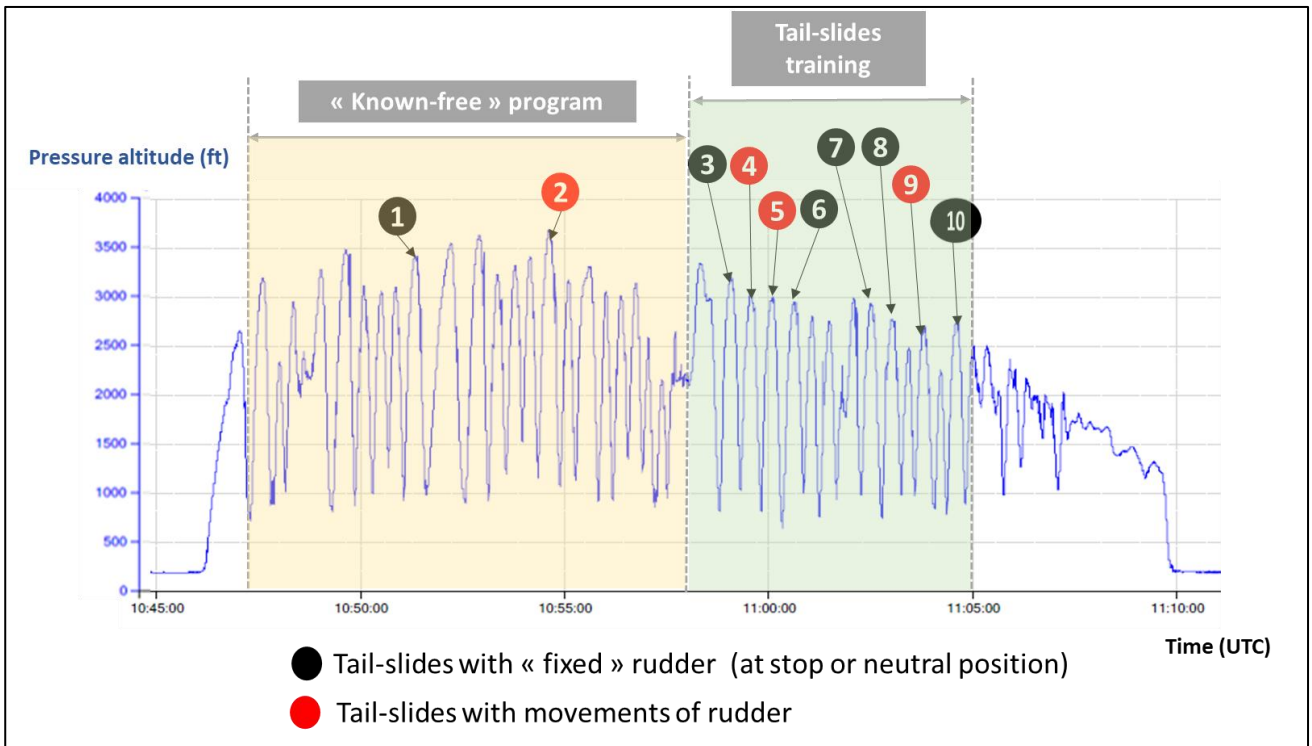
Figure 13 : flight profile (pressure altitude as a function of time) with identification of tail-slides performed

During the flight, the pilot performs the tail-slide maneuver 10 times: twice during his « known-free » program, and then eight times after the end of his program to practice this maneuver specifically following the radio debriefing with the coach.

The first two tail-slides of the flight are each preceded by a continuous roll, followed by a flick roll. The length of backward flight phases of the tail-slides are substantially identical, around 16 m, corresponding to approximately two lengths of the aircraft fuselage.
